REPORT NO. CG-D-2-77

LIGHTWEIGHT LIGHTED BUOY DEVELOPMENT  
FOR USE AS DISCREPANCY NAVAIDS

W. E. Colburn, Jr.  
and  
W. R. Thompson

December 1976

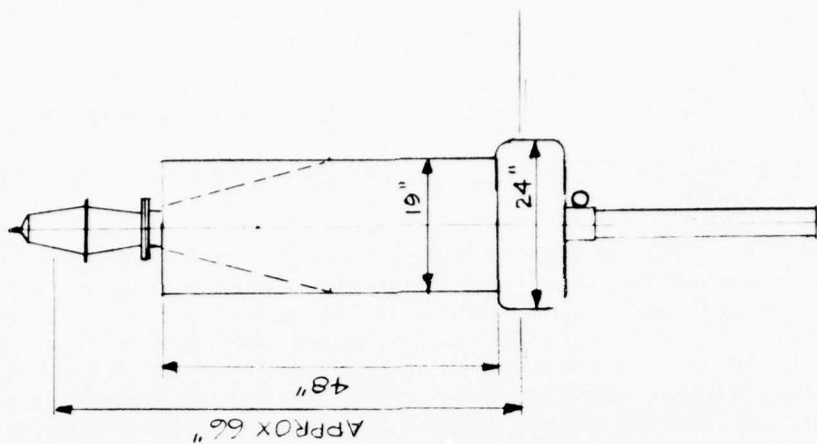
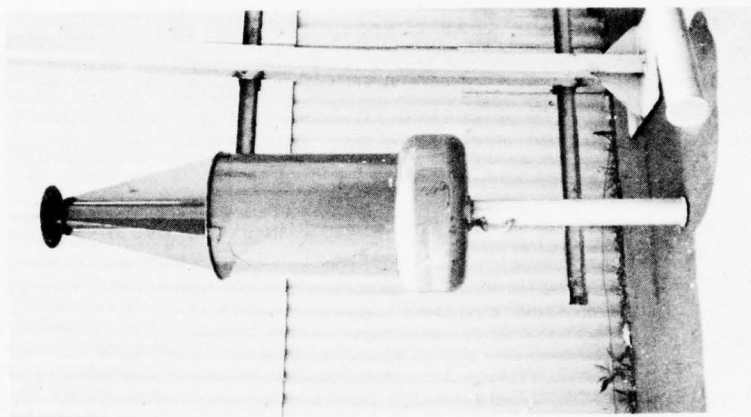
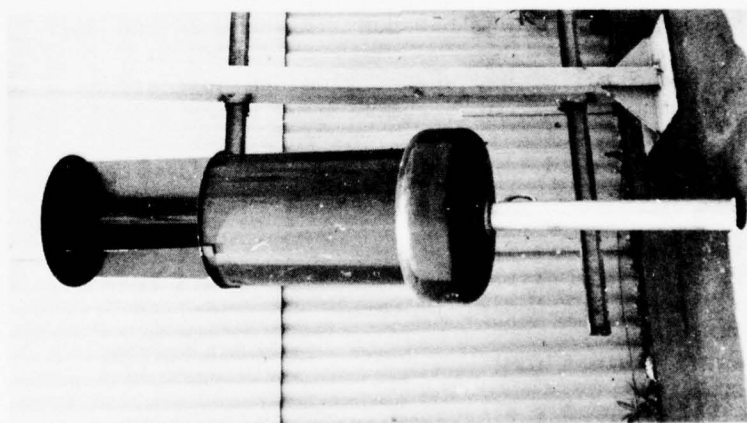
FIGURE 1A  
FIRST GENERATION MODIFIED BORG-WARNER SHELTERED WATER BUOY

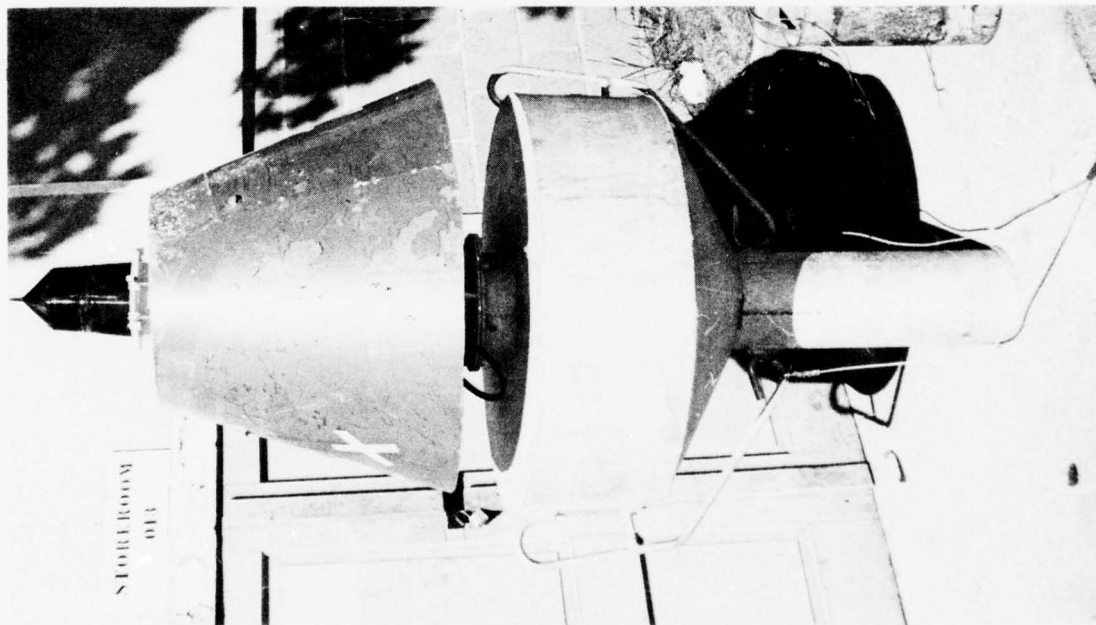
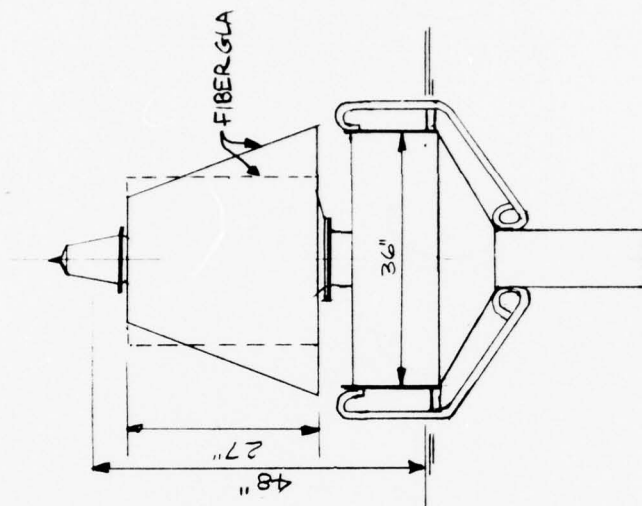
FIGURE 2A  
FIRST GENERATION ALUMINUM SHELTERED  
WATER DISCREPANCY BUOY (IGS, BEFORE  
MODIFICATION TO THE MOORING ATTACHMENT)

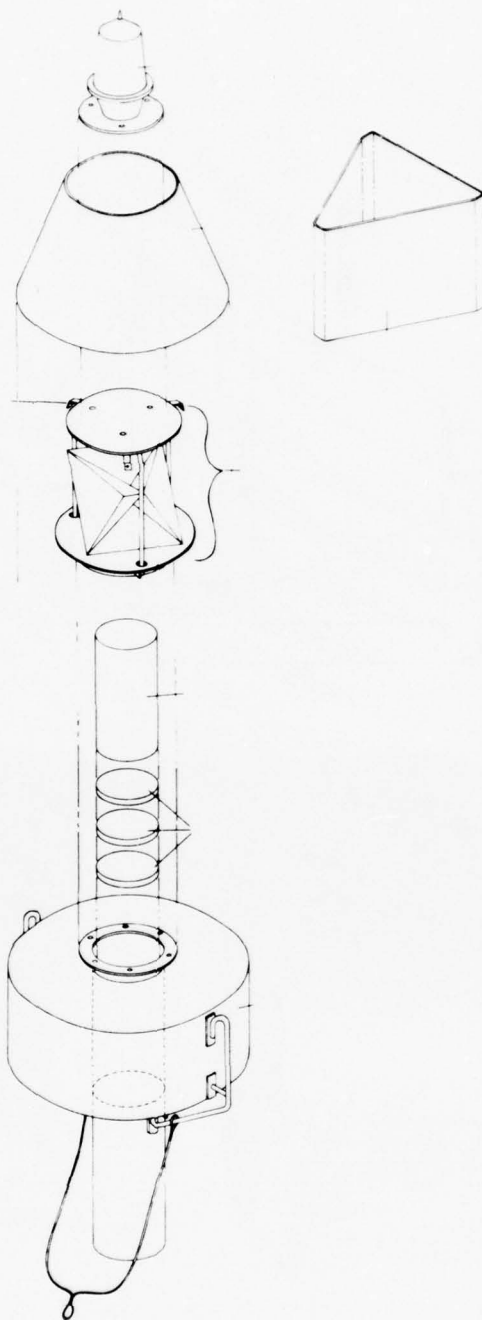
FIGURE 3A  
EXPLODED VIEW OF THE 1GS BUOY  
(BEFORE MODIFICATION TO THE MOORING ATTACHMENT POINT)

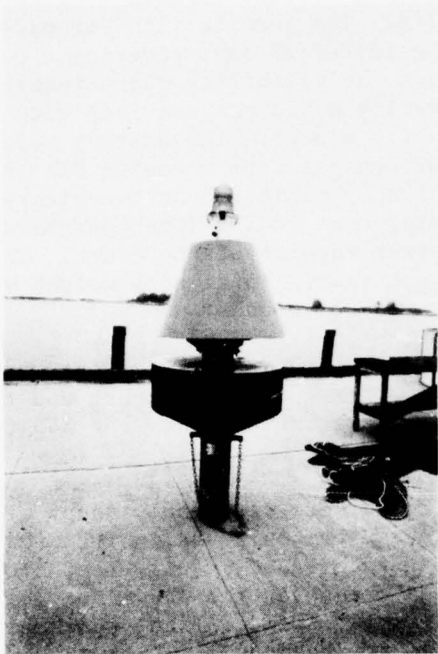
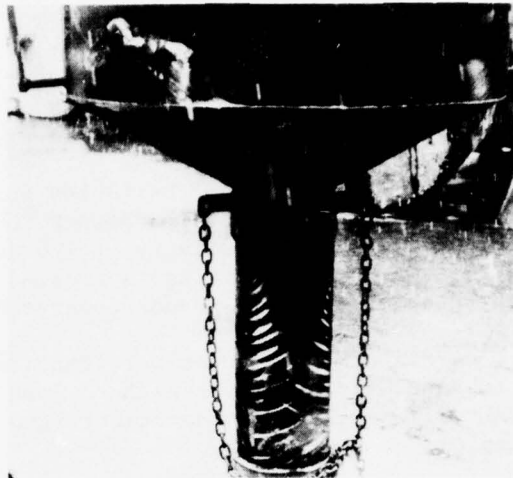
FIGURE 4A  
IGS BUOY AFTER MODIFICATION TO  
THE MOORING ATTACHMENT POINTS

Several problems arose during early deployments. The 1/4-inch stainless steel wire mooring bridle attachment points wore very quickly. In one case the aluminum rod attachment points were worn to 60% of their original area after only 39 days on station. Two buoys sank because of water flooding the hull. (One buoy was holed when it struck the wreck it was marking; the other had leaked through an air test fitting.) Field modifications were made to the buoys to correct these problems. The mooring bridle was changed to 1/4-inch galvanized chain, and the attachment modified such that all wear is on the last link of chain rather than on the buoy hull or fittings. Two-part polyurethane foam was expanded in the hull to provide positive buoyancy. The modified buoy is shown in Figure 4A.

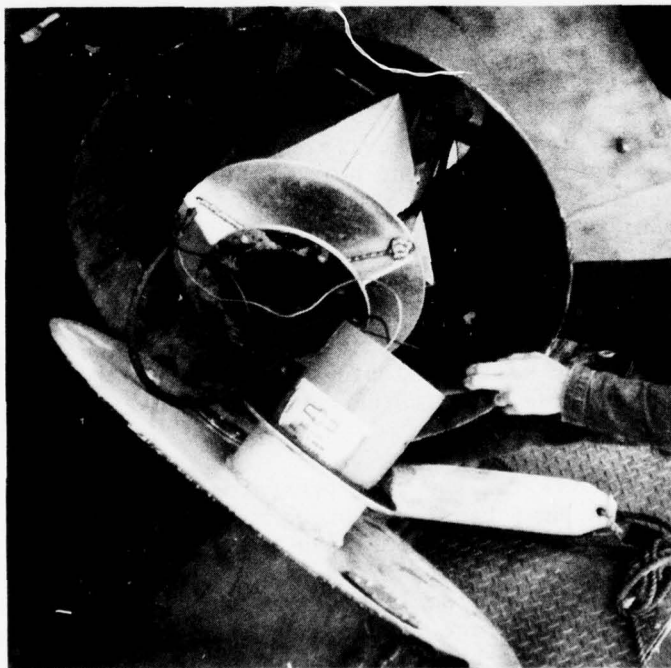
FIGURE 5A  
BATTERY REPLACEMENT ON THE IGS BUOY  
A-6

Servicing or recovery of the buoy presented operational problems. To replace the battery, the buoy had to be brought aboard the boat in order to remove the upper structure held in place by six bolts (Figure 5A).

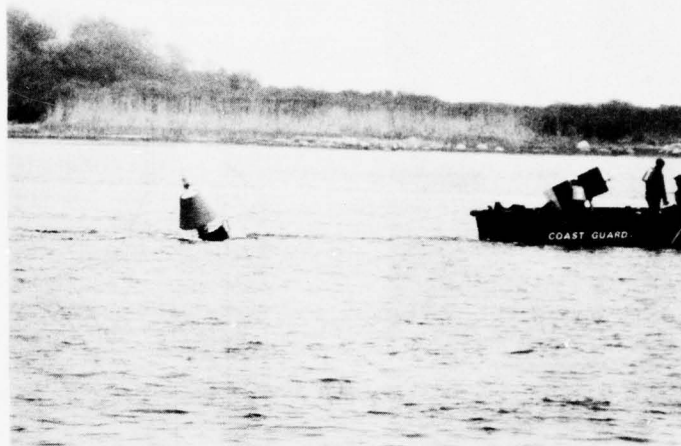
FIGURE 6A  
TOWING OF THE 1GS BUOY

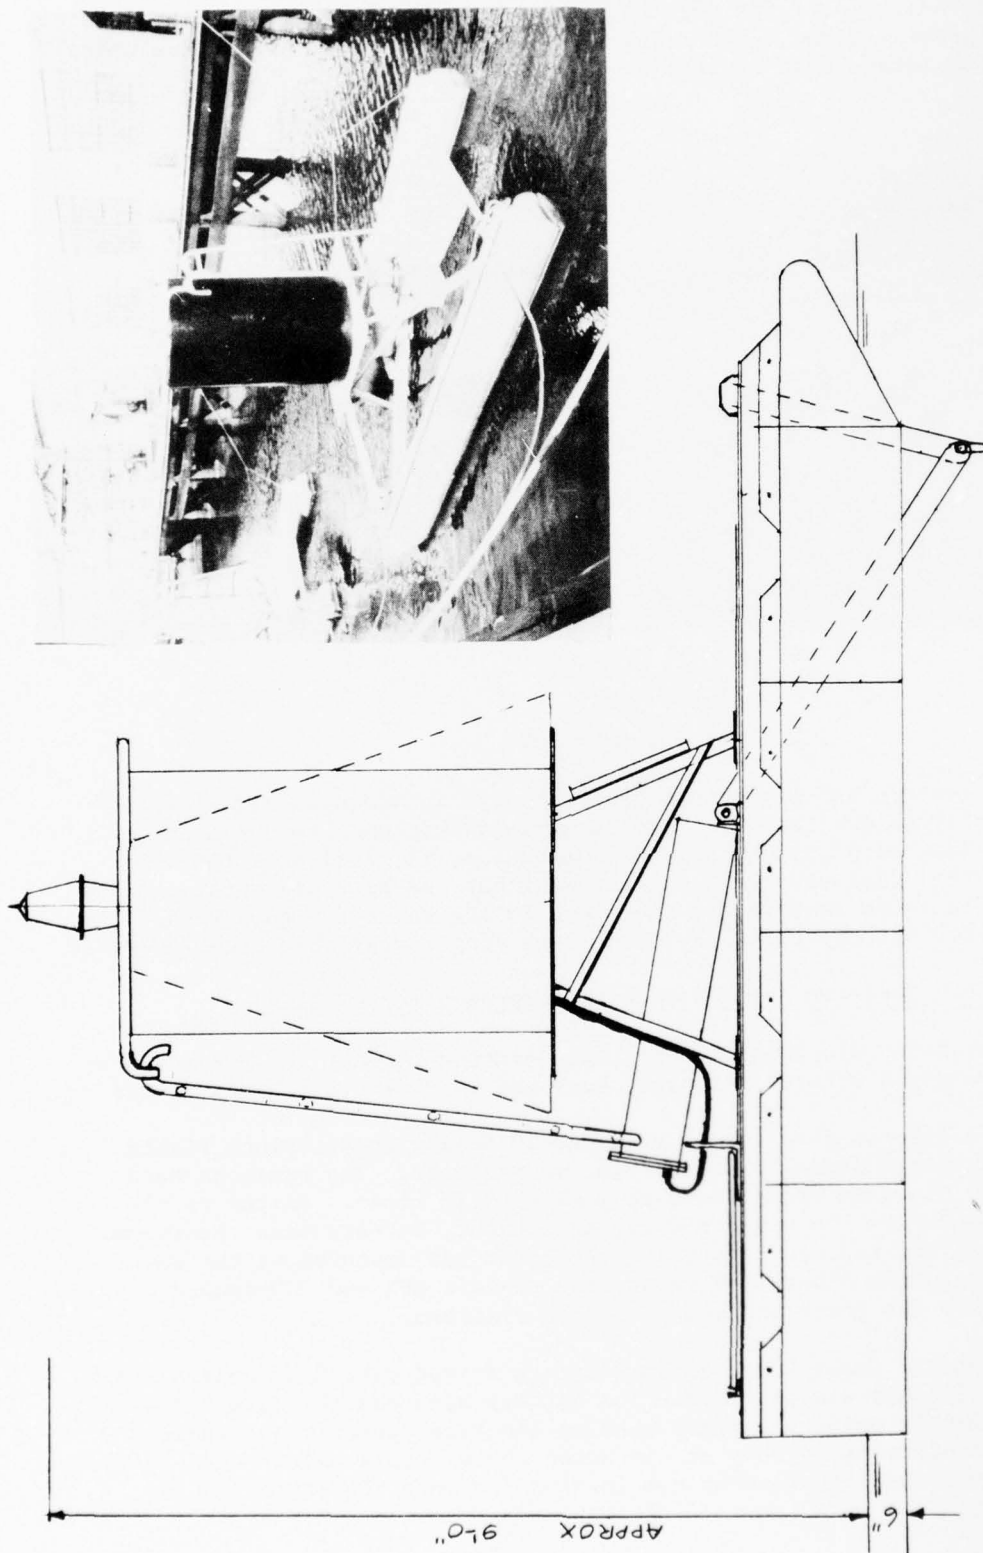
FIGURE 7A  
FIRST GENERATION EXPOSED WATER DISCREPANCY BUOY (1GE)  
BEFORE MODIFICATION TO THE MOORING ATTACHMENT

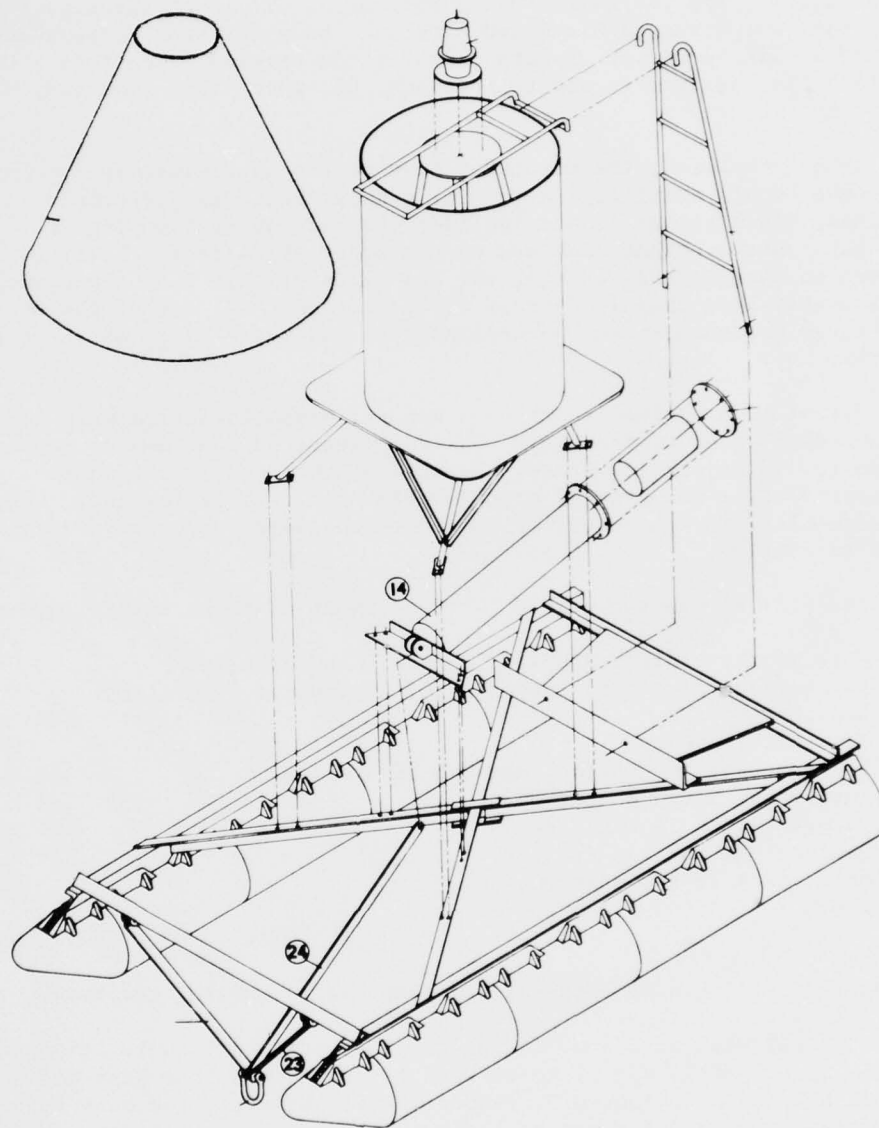
FIGURE 8A  
EXPLODED VIEW OF THE IGS BUOY  
(BEFORE MODIFICATION TO THE MOORING ATTACHMENT)

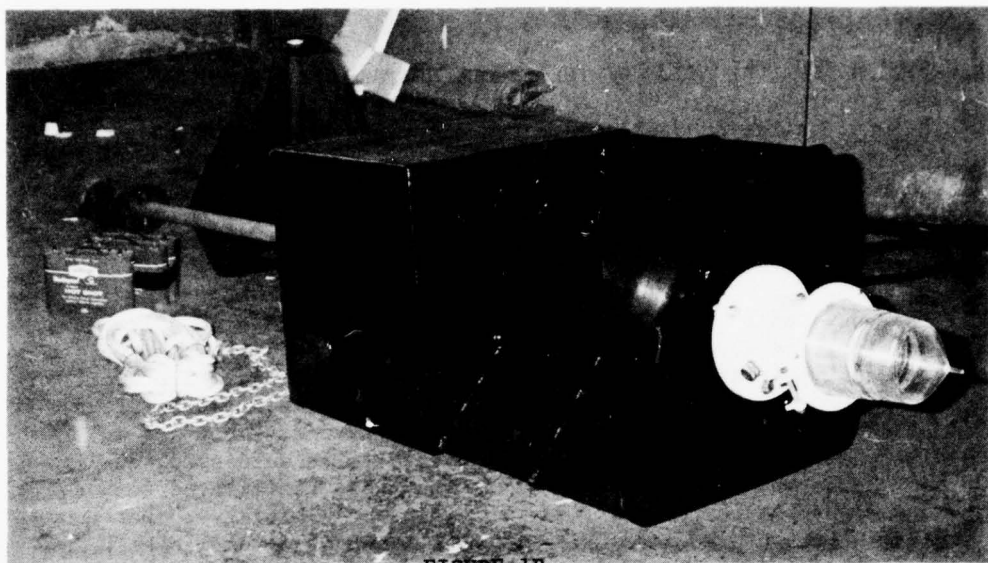
FIGURE 1B

SECOND GENERATION SHELTERED WATER DISCREPANCY BUOY (2GS) AND ASSOCIATED HARDWARE

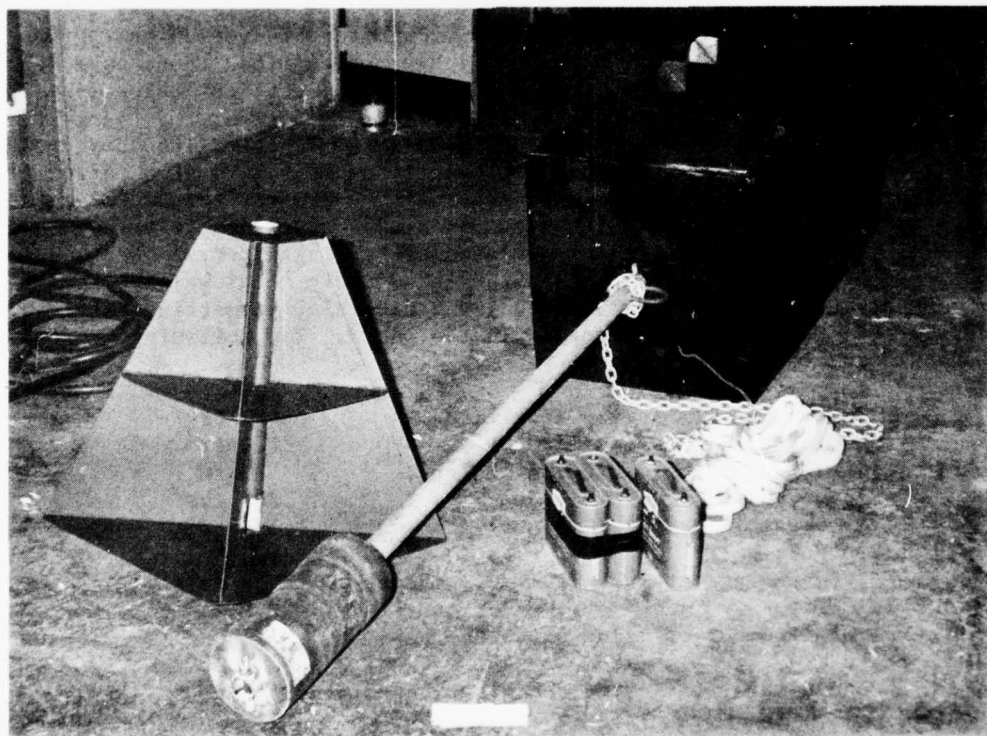
FIGURE 2B  
BATTERY COMPARTMENT OF THE 2GS BUOY

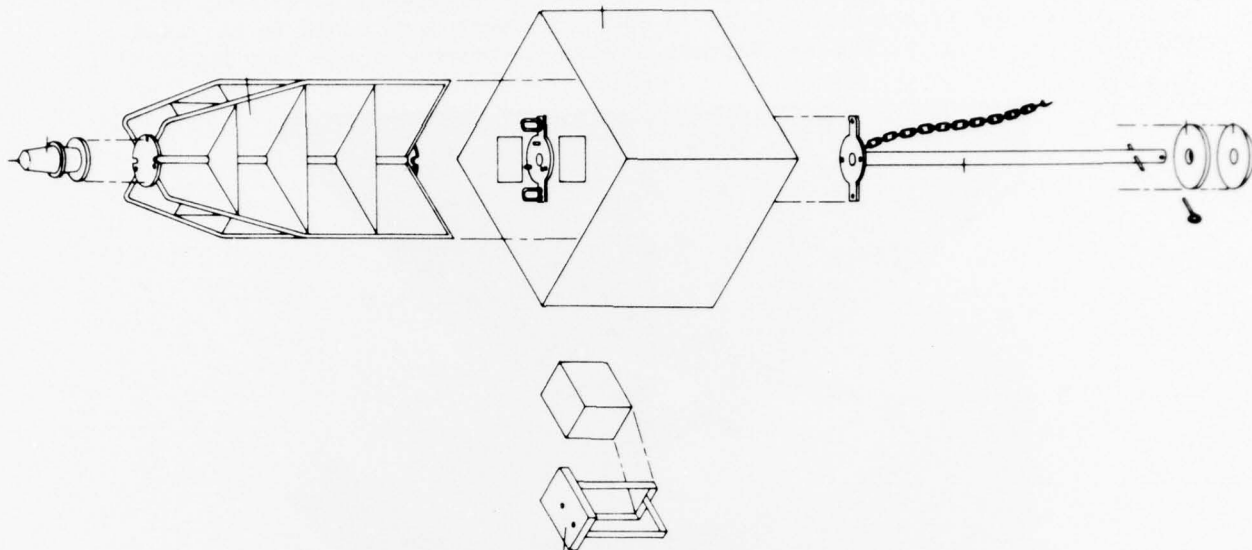
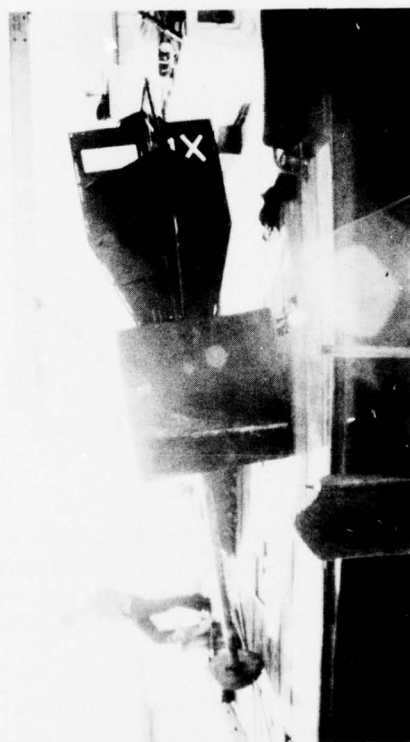
FIGURE 4B  
SECOND GENERATION EXPOSED WATER  
DISCREPANCY BUOY (2GE)

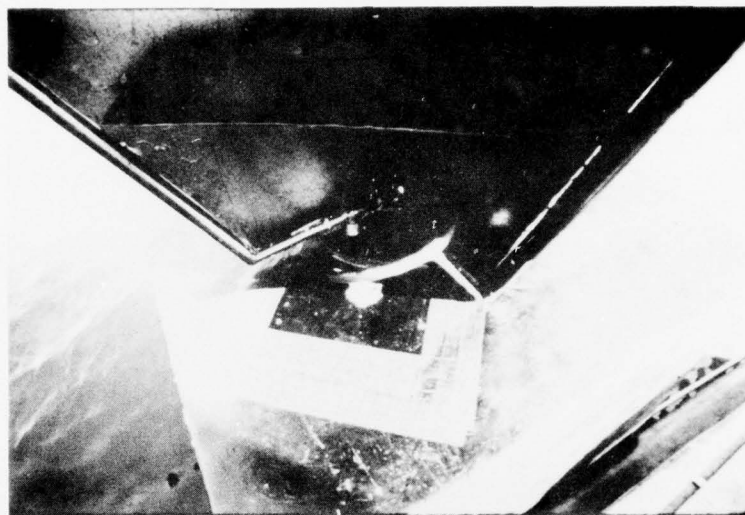
FIGURE 5B  
BATTERY STORAGE LOCATION IN THE 2GE BUOY

were wired in parallel. Tests conducted at the R&D Center indicated a usable life of 102 days for this battery combination while powering a 0.55 ampere lamp and a FI4(.4) characteristic at 32°F for 13 hours per day at a cutoff voltage of 10.8 volts. This selection actually resulted in a battery weight increase of 32 pounds but a cost savings of \$31 (initial) as compared to the primary batteries used in the catamaran buoy. Of more significance was the demonstrated ability to use readily available batteries. In an emergency situation, automobile batteries purchased en route to the deployment area could be utilized. Figure 5B shows one of the two battery storage locations in the buoy hull.

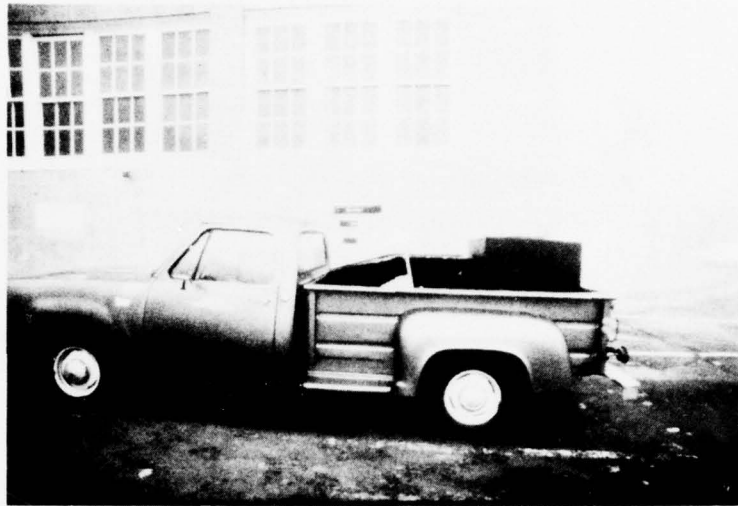
FIGURE 6B

TRANSPORT OF THE 2GE BUOY VIA PICKUP TRUCK

men and that could be transported in a 3/4 ton pickup truck. Assembly by two men in less than 3/4 hour was demonstrated. Figure 6B shows the transport of this buoy by pickup truck.

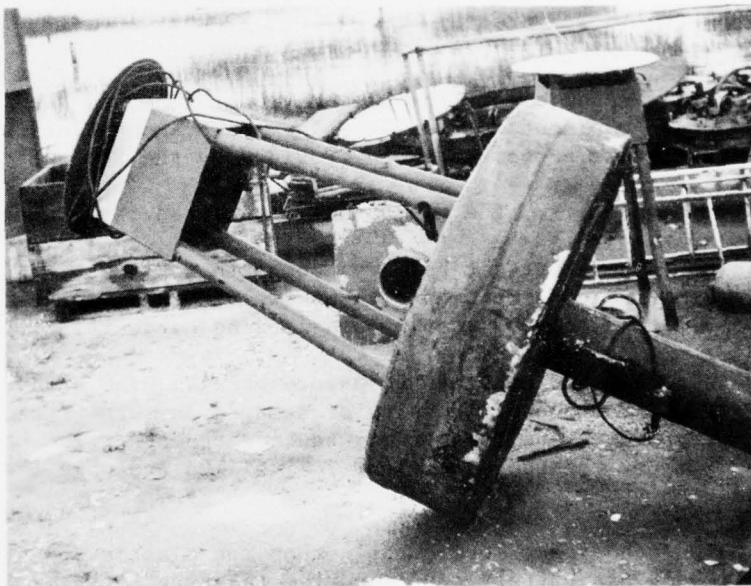
FIGURE 1C  
ALERP BUOY

The Base Mayport buoy, a later generation of the Seventh District's ALERP buoy, was of all aluminum construction and had a cylindrical foam-filled body penetrated by an aluminum "I" beam to which a concrete counterweight was attached at the lower end. Figure 1C shows the older ALERP buoy and Figure 2C shows the Base Mayport buoy.

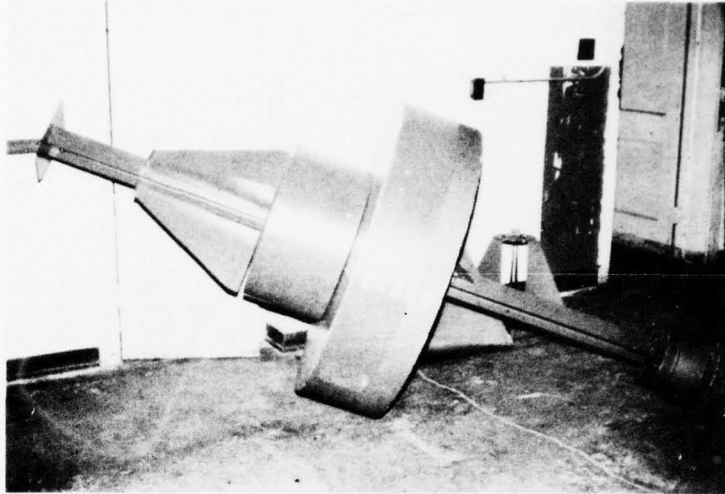
FIGURE 2C  
BASE MAYPORT BUOY

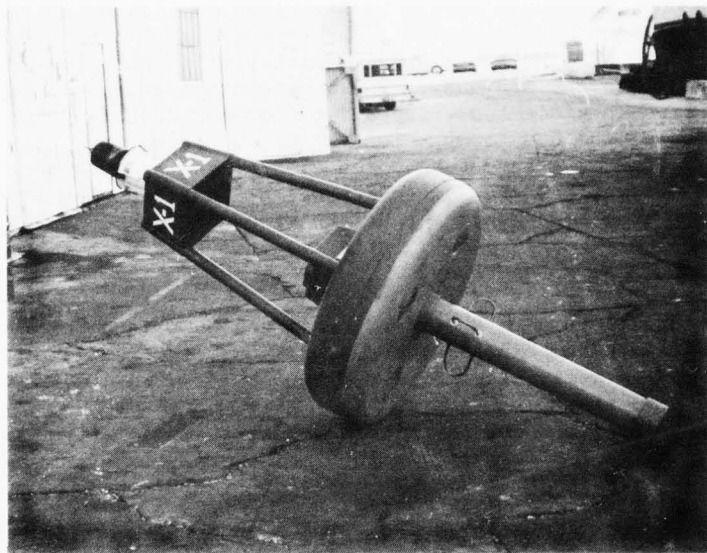
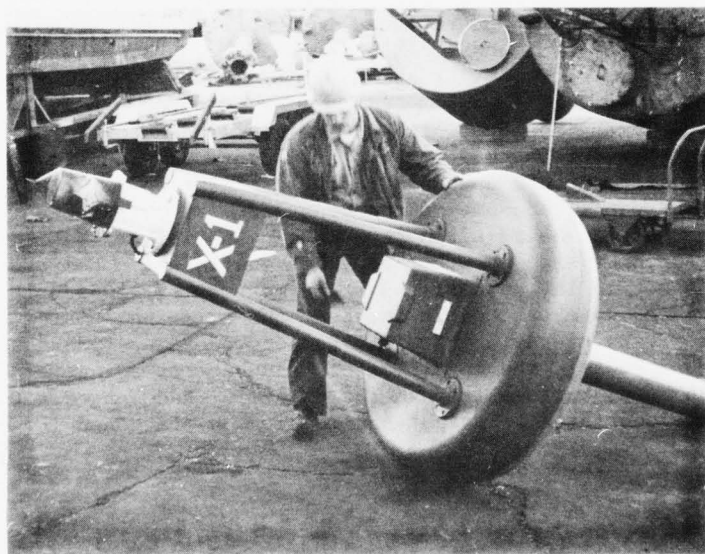
FIGURE 3C

BASE CHARLESTON BUOY (4-FOOT DIAMETER)

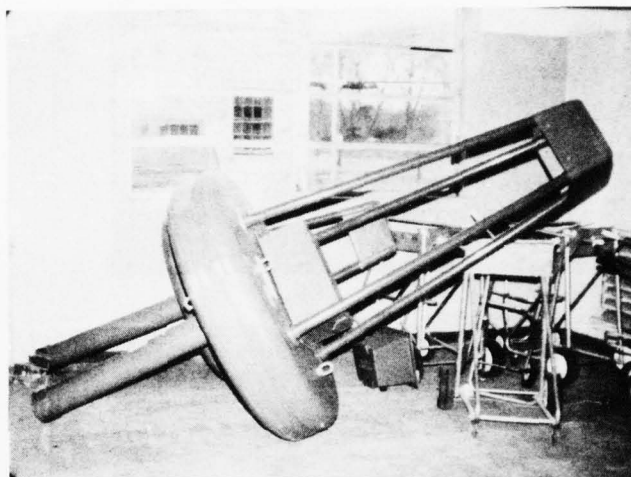
FIGURE 4C

BASE CHARLESTON BUOY (5-FOOT DIAMETER)  
(4-Foot Diameter Base Charleston Buoy Is In The Background)

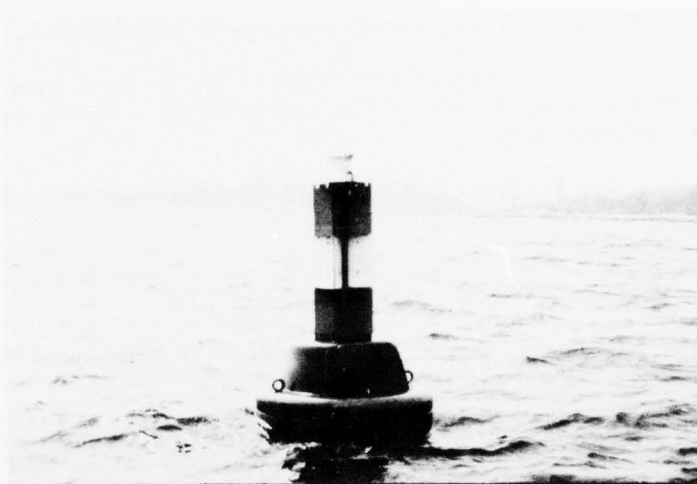
(a) THIRD GENERATION SHELTERED WATER DISCREPANCY BUOY (3GS)

The basic soundness of the Base Charleston buoy hull combined with its light weight led to development of the third generation buoys (Figure 1D).

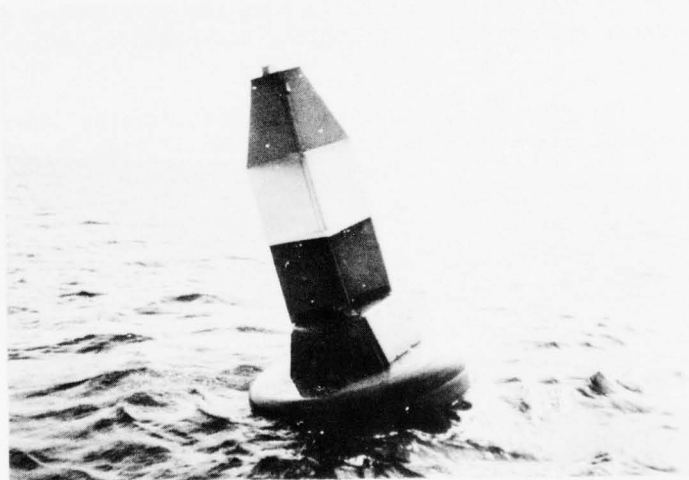
(b) THIRD GENERATION EXPOSED WATER DISCREPANCY BUOY (3GE)
